NASA
Technical Memorandum 86981

USAAVSCOM
Technical Report 85-C-4

Environmental Effects on the Tensile Strength of Chemically Vapor Deposited Silicon Carbide Fibers

April 1985

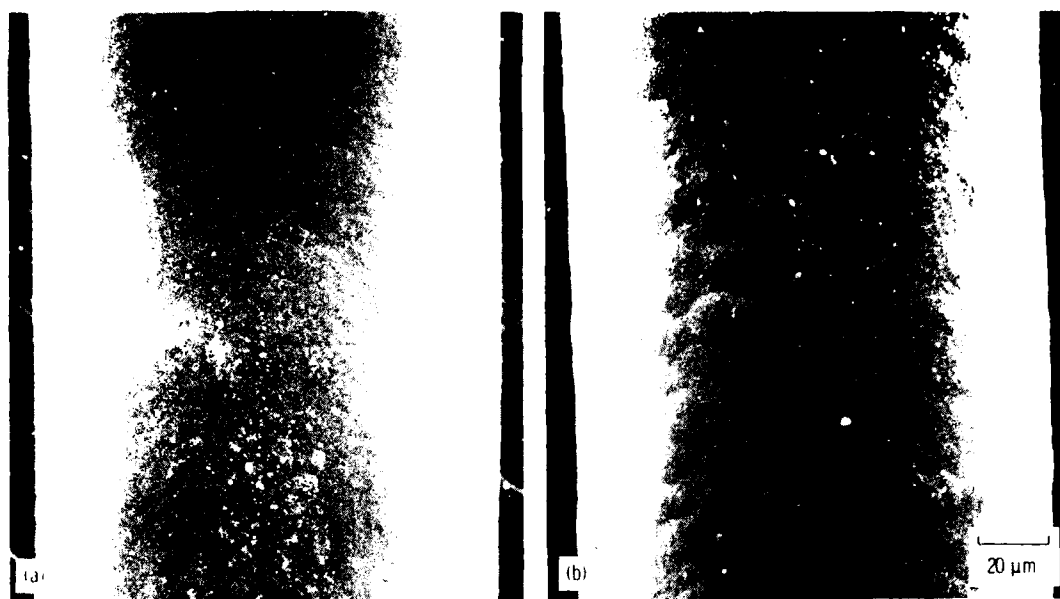
Figure 3. Photomicrographs showing surface microstructure on untreated, as-received carbon coated Saffil fibers, (a) Spool A; (b) Spool B.

3.1.1. SiC (C-coated) fibers. - As previously mentioned, the room temperature average tensile strengths of untreated spool A and spool B fibers were markedly different. Because the production years for each spool were different, this strength difference is attributed to changes in the manufacturing procedure. Furthermore, these fibers also showed significant differences in their surface microstructures. A representative photomicrograph of the fiber surfaces, shown in Fig. 3, reveals finer grains and a smoother surface in the high strength spool A fibers, and a larger corn cob structure and coarser surface in the low strength spool B fibers. Due to the explosive nature of fiber fracture at these high strength levels, original fracture surfaces could not be retained for analysis of the strength-controlling flaws in the as-received fibers.

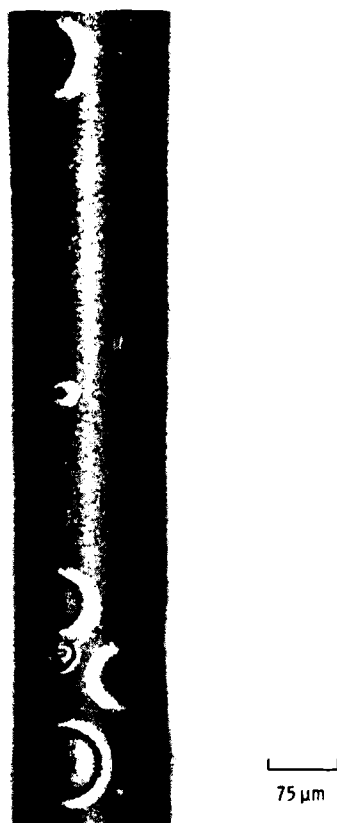
Figure 12. - Photomicrographs of SCS-6 fiber heated at 1200 °C in oxygen for 15 minutes showing pits and pinhole porosity on the surface.

To determine the cause of strength degradation in SCS-6 fibers, microstructural and fractographic analysis were conducted whenever possible. Examination of the surface of the fibers heated in oxygen at temperatures in excess of 800 °C showed silica, pits, and pinhole porosity (Fig. 12). The number of pits seen on the fiber surface increased with increasing temperature of exposure. At very high temperatures (>1300 °C), in addition to pits, bubbles were also seen on the fibers. In comparison, SCS-6 fibers heated in argon or in a vacuum environment showed only a few pits on the surface. In most cases, examination of the primary fracture surfaces of the broken fiber indicated that the surface flaws (pits, bubble,) are the source of fracture.
